This spreadsheet performs screening level calculations to estimate the effect of peeling leaded paint on the average concentration of lead in yard soil
3548 Gilpin Street

LBP Assessment Results

Property ID # 2670 / 3548 Gilpin Street

SITE NAME: VASQUEZ BOULEVARD AND I-70

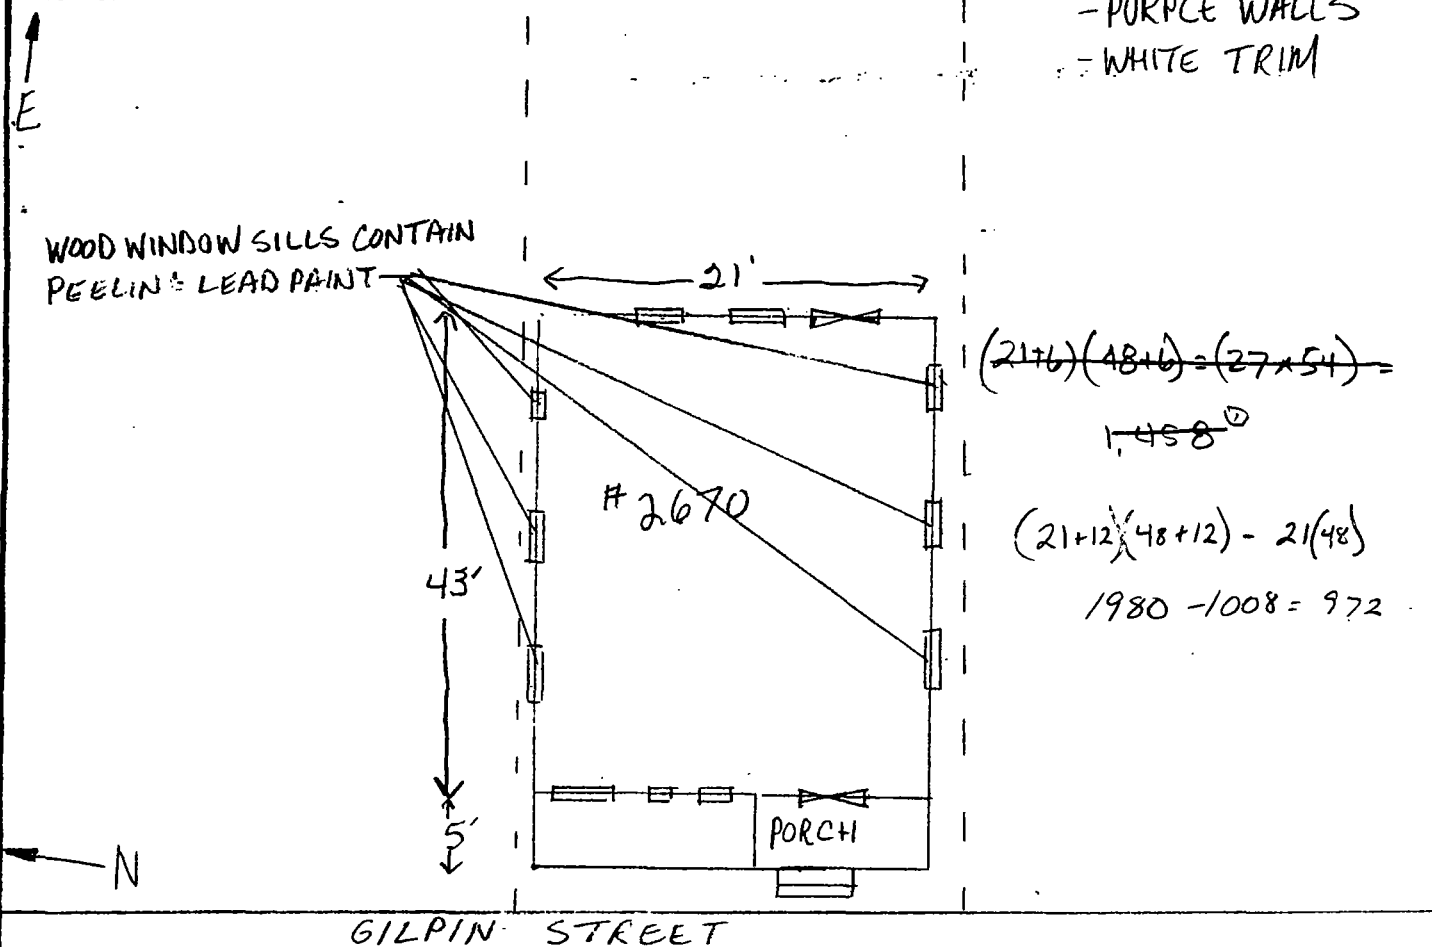
Plot Plan:

Exterior Walls				Doors/Trim			
	Material	Area	Peel/Chip	XRF (Lead)	Material	Area	Peel/Chip	XRF (Lead)
North	BRICK	410'±	CRACKED	24.2				
South	BRICK	410'±	CRACKED	6.5				
East	BRICK	150'±	CRACKED	1.4				
West	BRICK	210'±	CRACKED	2.0

Window Trim/Fascia/Soffit				Patios/Decks/Porches			
	Material	Area	Peel/Chip	XRF (Lead)	Material	Area	Peel/Chip	XRF (Lead)
North	WOOD	6'±	PEEL	2.3	WOOD CEILING	50'±	CRACKED	17.9
South	WOOD	6'±	PEEL	1.2				
East	CEMENT	—	—	—	WOOD COLUMN	2'±	—	29.9
West	WOOD	—	—	—	WOOD COLUMN	12'±	CRACKED	29.5

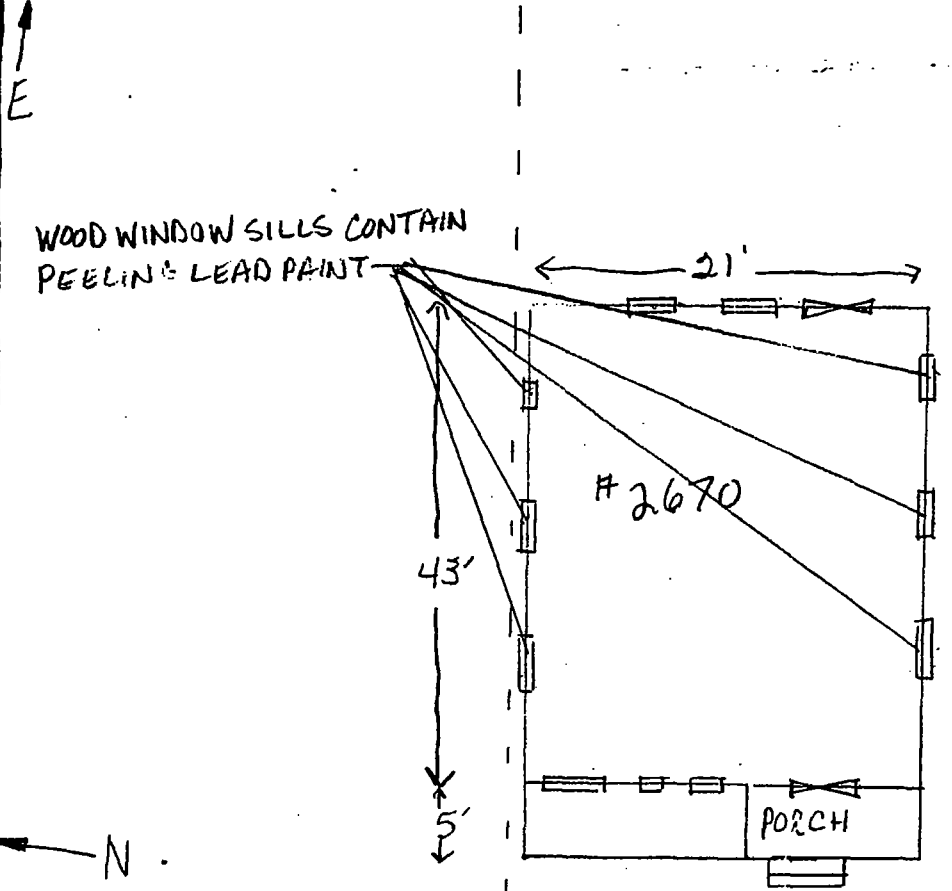
Plot Plan:

- PURPLE WALLS
- WHITE TRIM

Exterior Walls				Doors/Trim			
Material	Area	Peel/Chip	XRF (Lead)	Material	Area	Peel/Chip	XRF (Lead)
BRICK	410'	CRACKED	24.2				
BRICK	410'	CRACKED	6.5				
BRICK	150'	CRACKED	1.4				
BRICK	210'	CRACKED	2.0

Window Trim/Fascia/Soffit				Patios/Decks/Porches			
Material	Area	Peel/Chip	XRF (Lead)	Material	Area	Peel/Chip	XRF (Lead)
WOOD	6'	PEEL	8.3	WOOD CEILING	50'	CRACKED	17.9
WOOD	6'	PEEL	1.2				
CEMENT	—	—	—	WOOD COLUMN	2'	—	29.9
WOOD	—	—	—	WOOD COLUMN	12'	CRACKED	29.5
